Understanding **MP6500** Current Control

Application Note

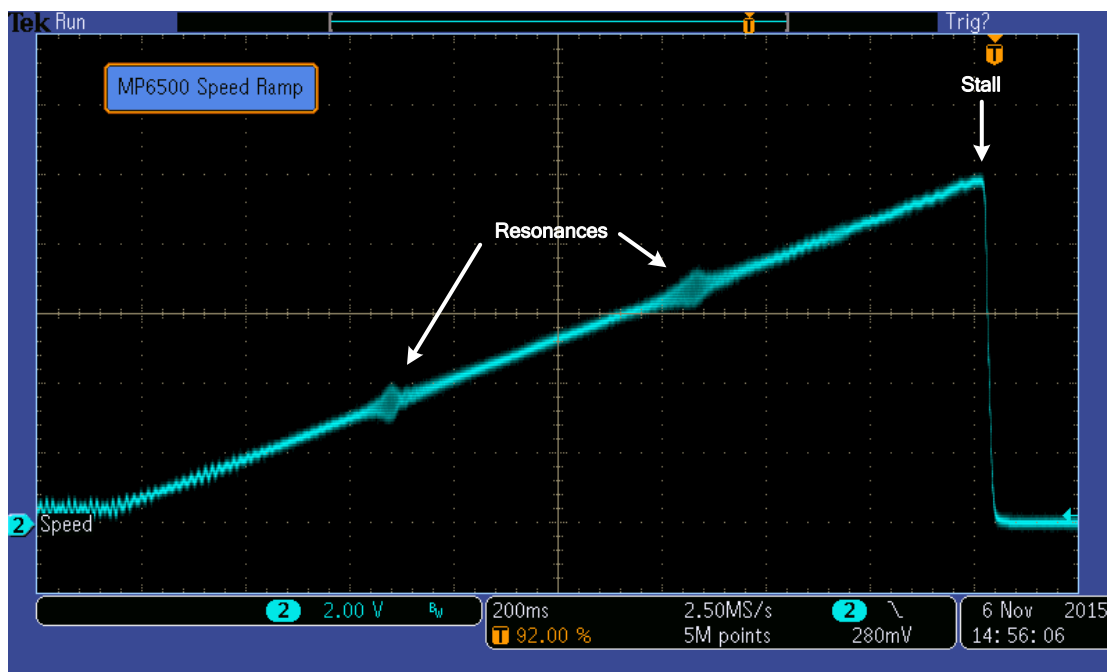
Using the same setup and winding current, the MP6500 shows the ability to drive to a significantly higher speed (see Figure 15). A stall occurs at a measurement voltage of about 10V, which corresponds to around 600RPM. This is due to improved current regulation at high step rates.

Figure 15: MP6500 Speed Ramp
