Understanding **MP6500** Current Control

Application Note

Prepared by Pete Millett

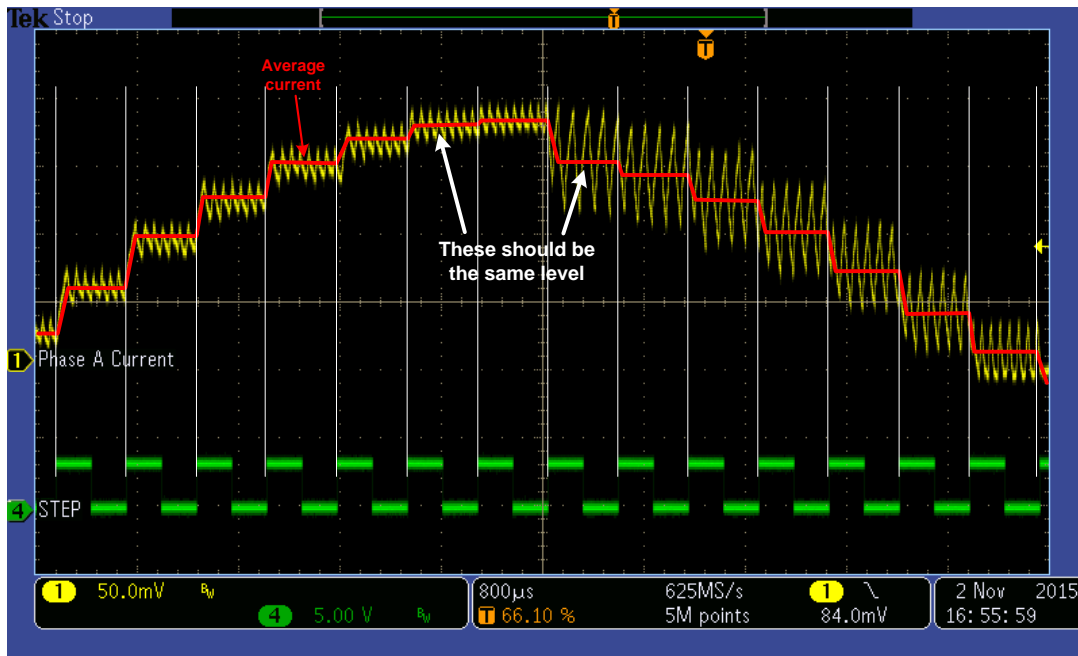
Figure 4: Conventional Current Regulation Waveform

To prevent this situation, many stepper motor driver ICs implement schemes where slow decay is used only as the current is driven away from zero and use fast or mixed decay (a combination of fast and slow decay) to drive the current toward zero. However, the average current regulated with slow decay and fast decay is quite different due to the increased current ripple in fast decay mode. This results in errors in the average current level and poorer motion quality (see Figure 4).

In the waveform above, the motor moves more in the step after the peak current than in the step before the peak current. This results in a position error and instantaneous speed variation. A similar jump occurs as the current waveform crosses zero.

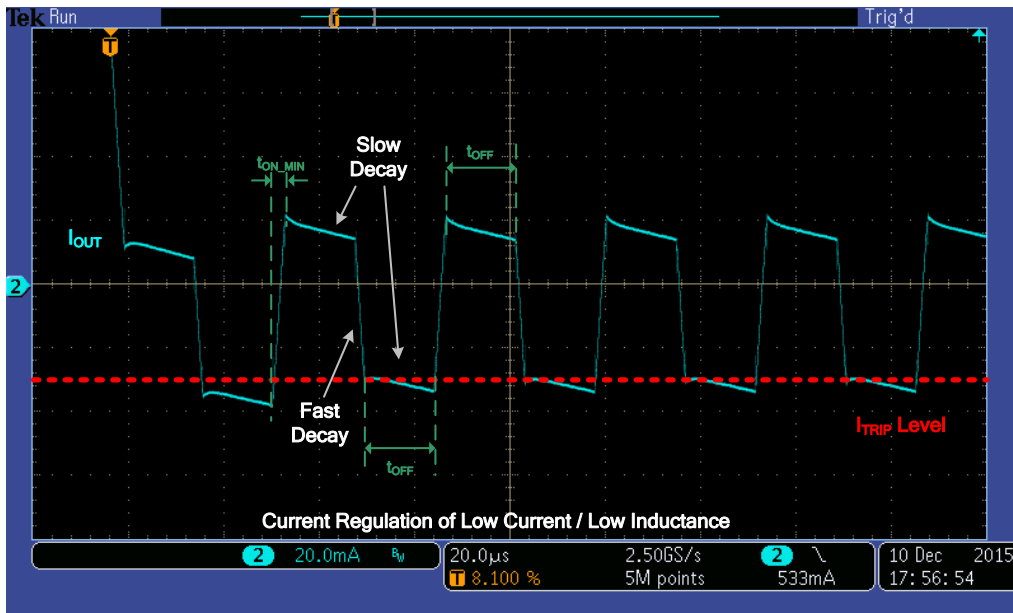
Figure 7: MP6500 Auto-Decode at Low Current

In cases where the supply voltage is high, the inductance is low or the desired current regulation level is very low, so it is possible that the current will increase above the desired regulation level significantly. This occurs during the blanking time, which results in a minimum PWM on time at the beginning of the PWM cycle. This causes many legacy stepper motor drivers to lose control of the winding current. In the MP6500, if this occurs, fast decay cycles are used to drive the current below the desired level (see Figure 7).

A small shift in the average current can still be seen compared to the regulation using only slow decay. Since fast decay is only used long enough to drive the current below the desired level, the error is much less than if fast decay were to be used for the entire PWM off time.

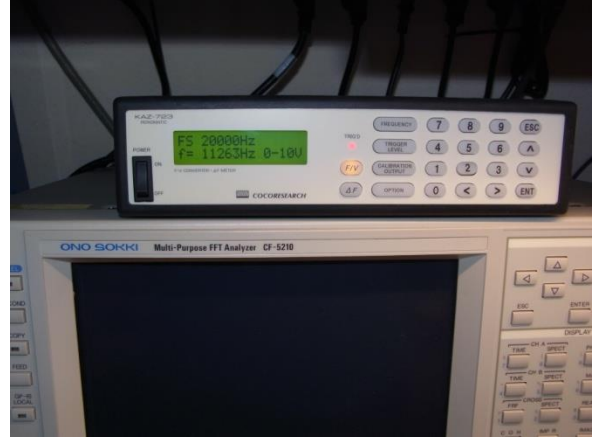
Figure 10: KAZ-723 F/V Converter

To make measurements of the motion, a frequency-to-voltage converter (Coco Research KAZ-723) was used to process the output of the optical encoder with its output observed on an oscilloscope and FFT analyzer. This output is a voltage that is representative of the motor speed updated at a very high rate.

This setup is shown in Figure 9 and Figure 10.

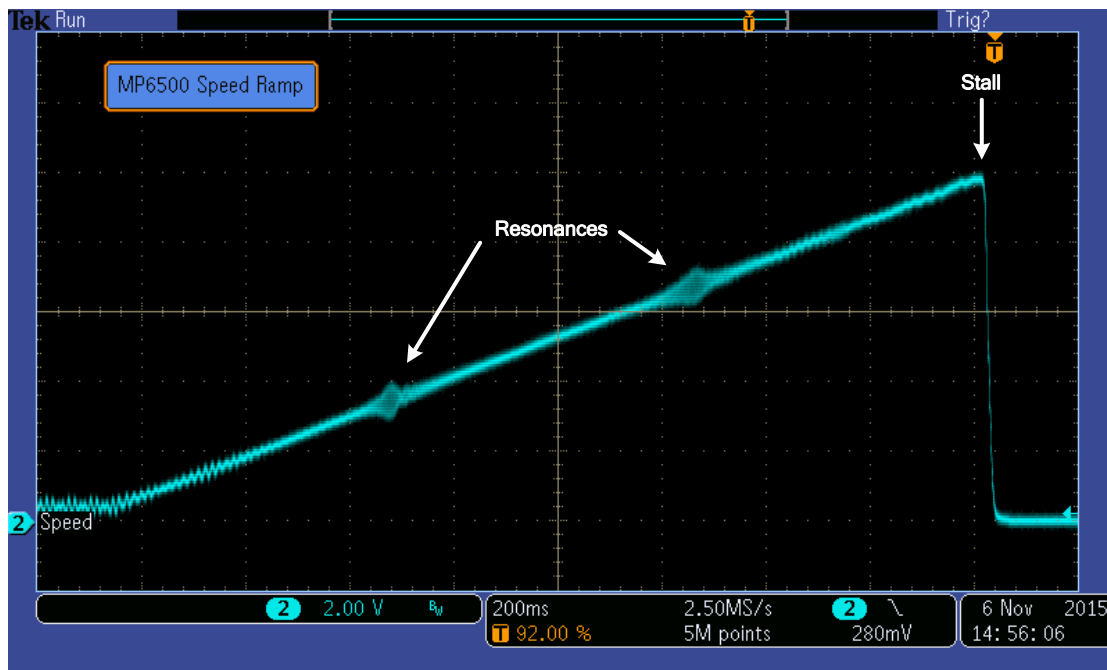
Figure 15: MP6500 Speed Ramp

Using the same setup and winding current, the MP6500 shows the ability to drive to a significantly higher speed (see Figure 15). A stall occurs at a measurement voltage of about 10V, which corresponds to around 600RPM. This is due to improved current regulation at high step rates.
